Rincon Consultants, Inc.

July 26, 2022 Project No: 21-11698

Subject: Revised Biological Resources Technical Memorandum for the 2364 Road 20 Development Project San Pablo, Contra Costa County, California

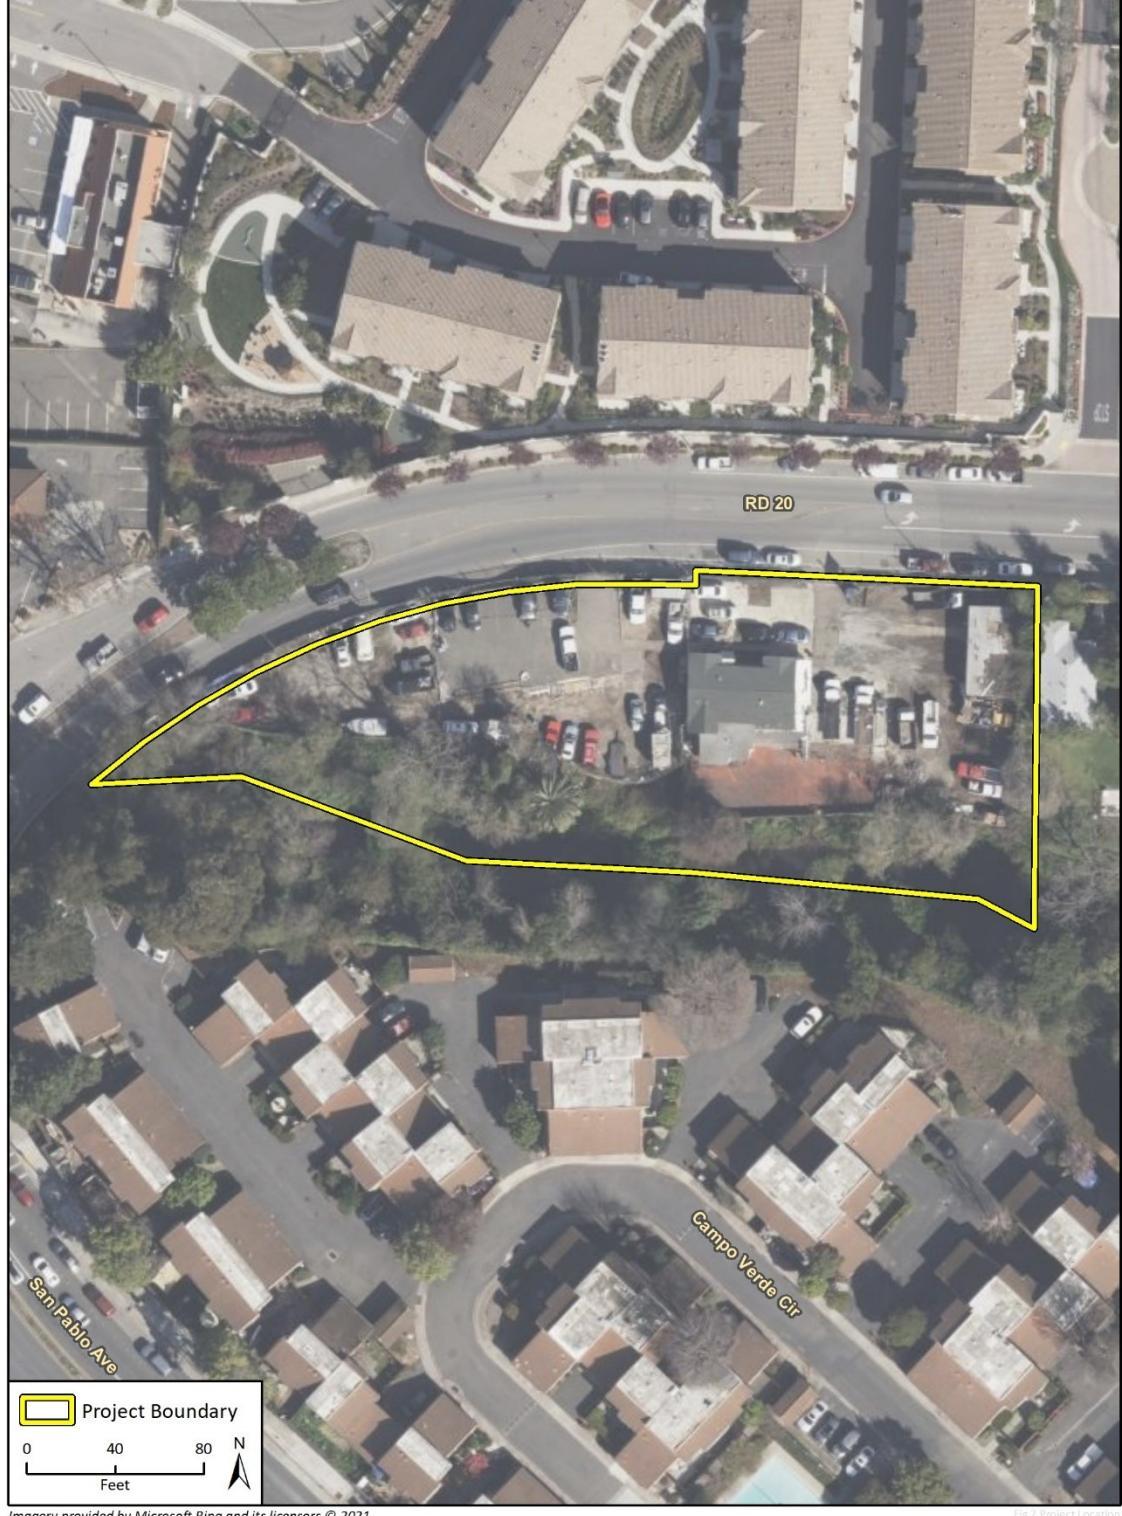
Figure 2 Project Location

The project proposes construction of a new multi-family five story residential building on the existing developed area of a 0.98-acre parcel (APN 416-120-029) southeast of the Road 20 and San Pablo Avenue intersection (Attachment A, Figures 1 and 2). The development will include 64 rental units, a parking garage, surface parking, and parking lifts. San Pablo Creek runs along the southern end of the parcel.

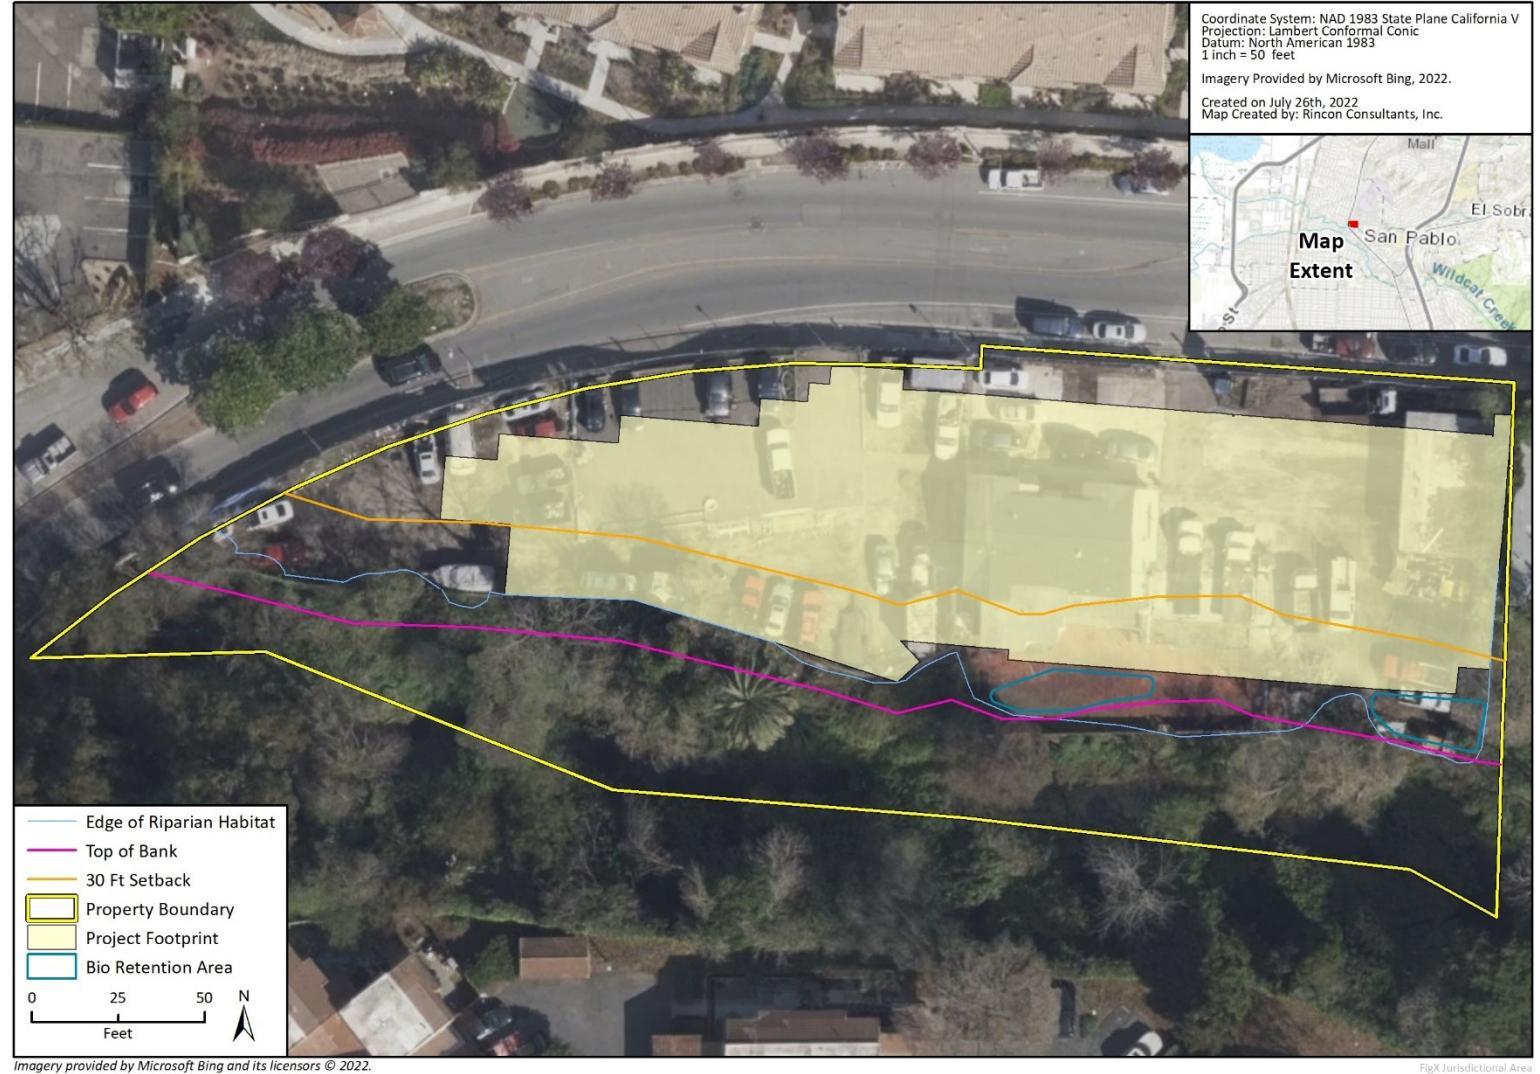
Figure 3 Project Footprint and Riparian Habitat

Local ordinance requires a 30-foot setback from the creek top of bank; however, the project is requesting a variance with parking areas, access driveways, paved pedestrian walkways, and bioretention areas planned within portions of the setback. No walls or structures are planned for construction within the setback. It should be noted that two existing decks on the parcel extend through the setback and over the creek top of bank. These decks will be removed as part of the project.

The project site includes developed area on the northern half of the site along Road 20, and a fragment of riparian woodland along San Pablo Creek at the southern edge of the site. (Attachment A, Figures 2 and 3). The developed area of the site is paved or graveled and surrounded by wooden or chain-link fencing (see photos in Attachment B). Existing structures occur on the eastern half of the site, including a house with an attached deck that extends south towards the creek, a large shed at the northeast corner of the site, and a smaller deck at the southeastern edge of the site. The house is currently occupied by tenants who operate a tow truck company from the site. A paved area on the western half of the site is used as a parking lot.

The project footprint as currently designed would not impact riparian habitat or other jurisdictional areas surrounding San Pablo Creek. If any trees or vegetation must be impacted as part of construction, the City of San Pablo's General Plan (Implementing Policy OSC-I-8) requires scheduling of construction and vegetation removal outside of nesting bird season or conducting a preconstruction nesting bird survey. If removal of mature trees is required, the General Plan (Implementing Policy OSC I-9) requires a pre-construction acoustic survey to determine if bats are present. Any disturbance to San Pablo Creek water quality through removal of the deck structures will be avoided through implementation of best management practices, such as a stormwater pollution prevention plan, as required by Implementing Policy OSC I-9 in the General Plan and the Municipal Code (Chapter 17.40). Because protecting nesting birds, roosting bats, and water quality is standard city policy and would be implemented as a condition of approval for the project, potentially significant impacts to special status species and their habitats will be avoided.

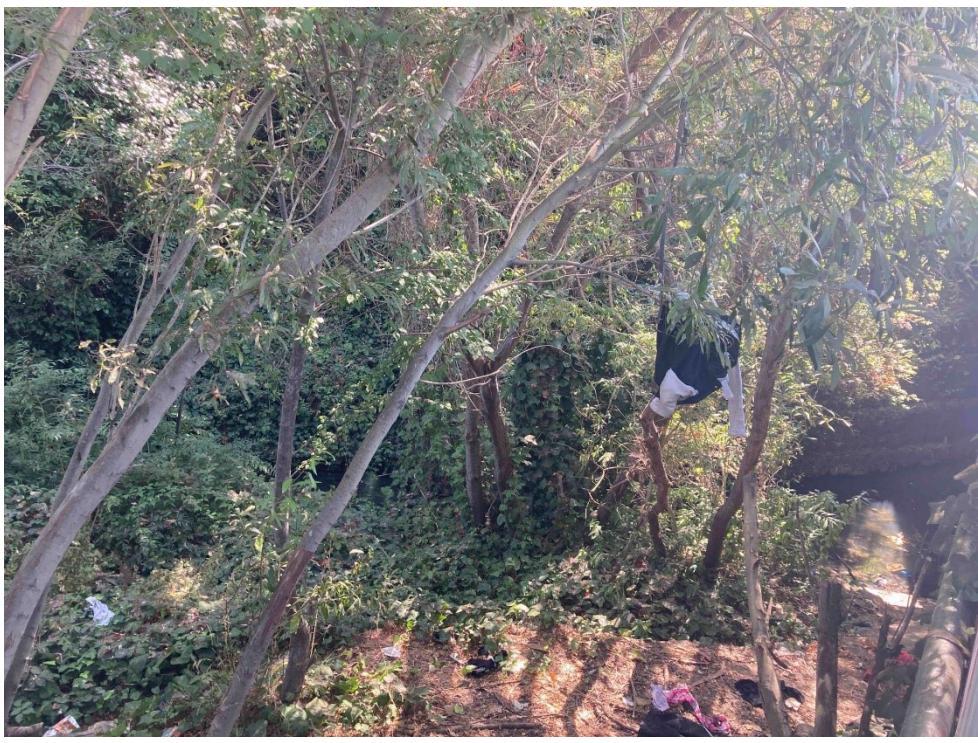
Photograph 1. San Pablo Creek at east side of culvert under San Pablo Avenue, facing south-southwest.

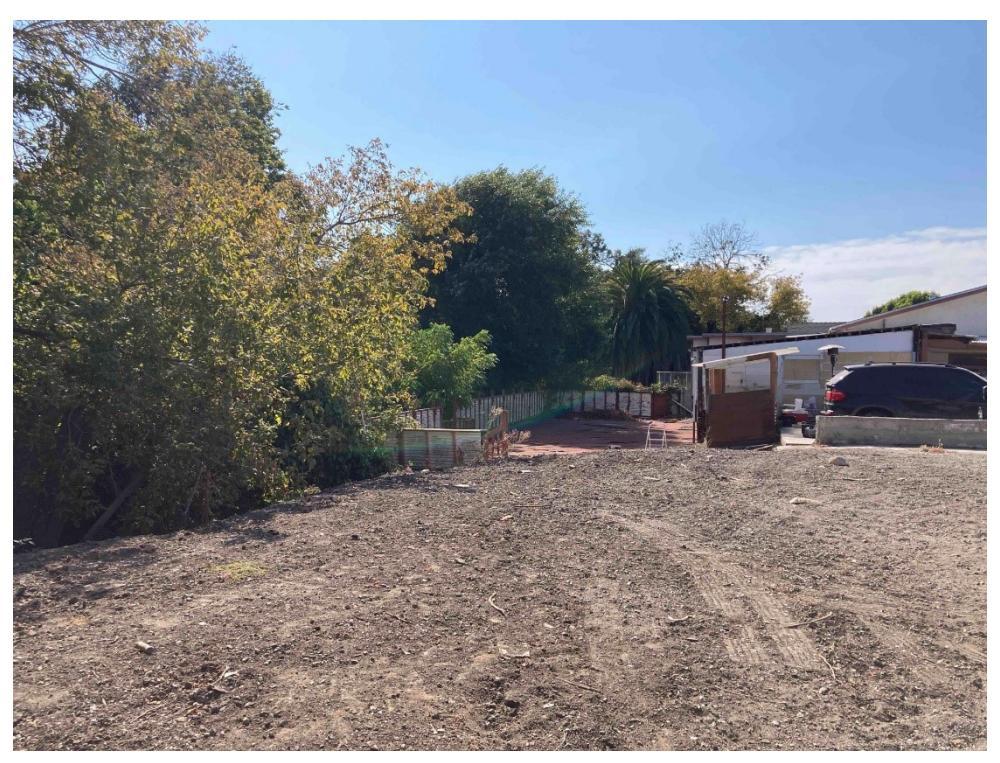
Photograph 2. View of larger deck adjacent to house, facing west-southwest.

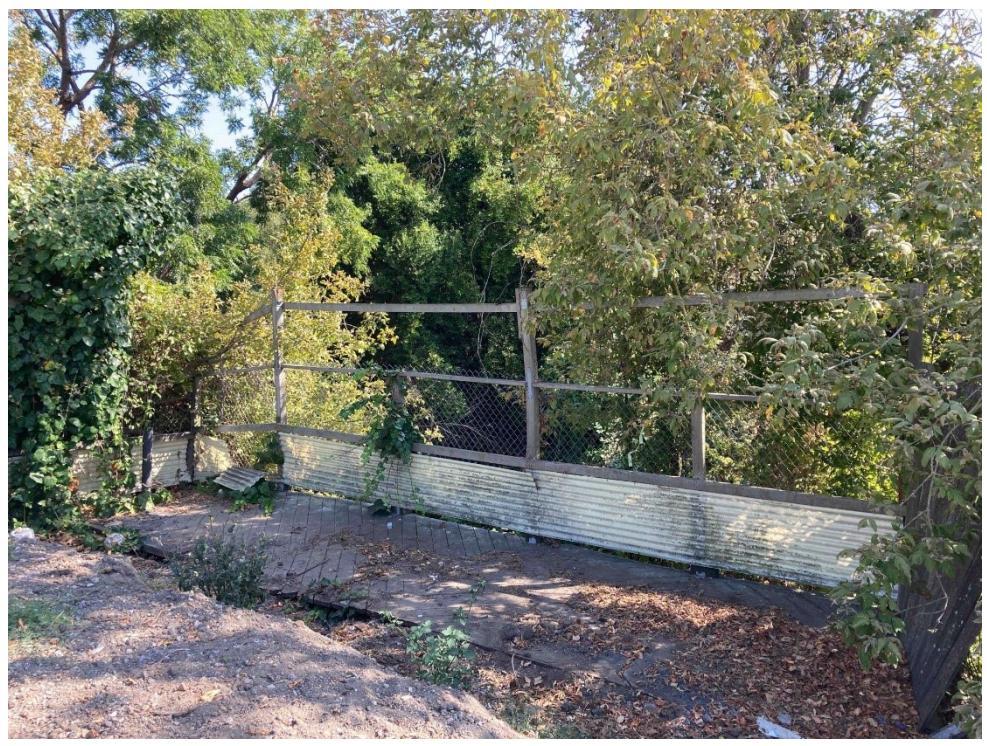
Photograph 3. View of smaller deck at southeast corner of property, facing south-southeast.

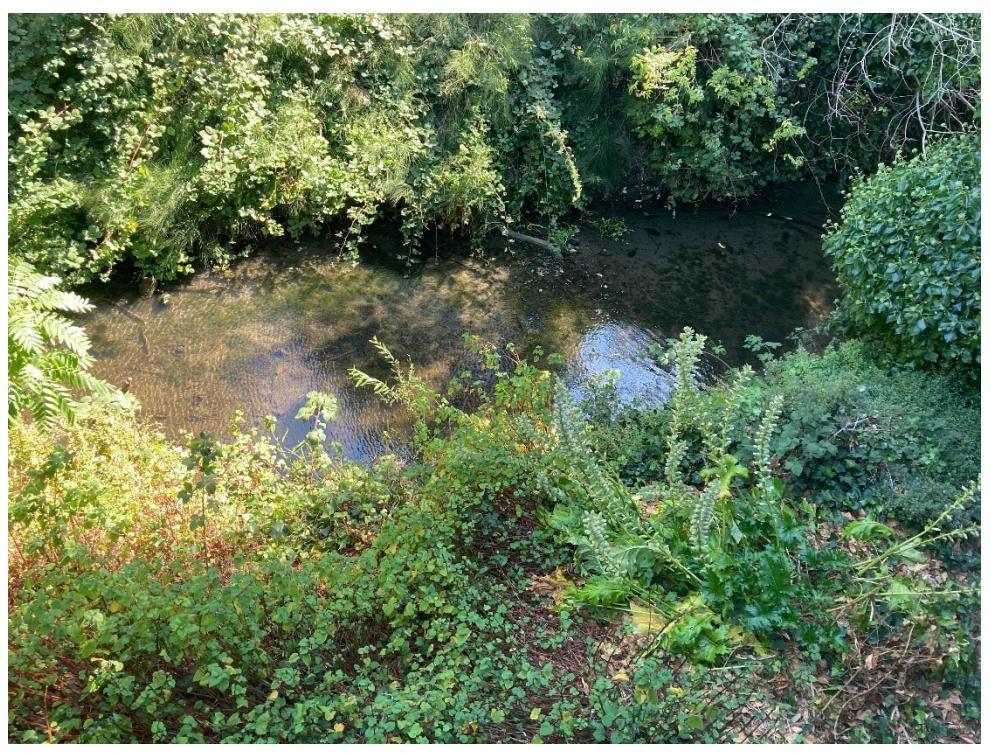
Photograph 4. View of San Pablo Creek from larger deck, facing south.

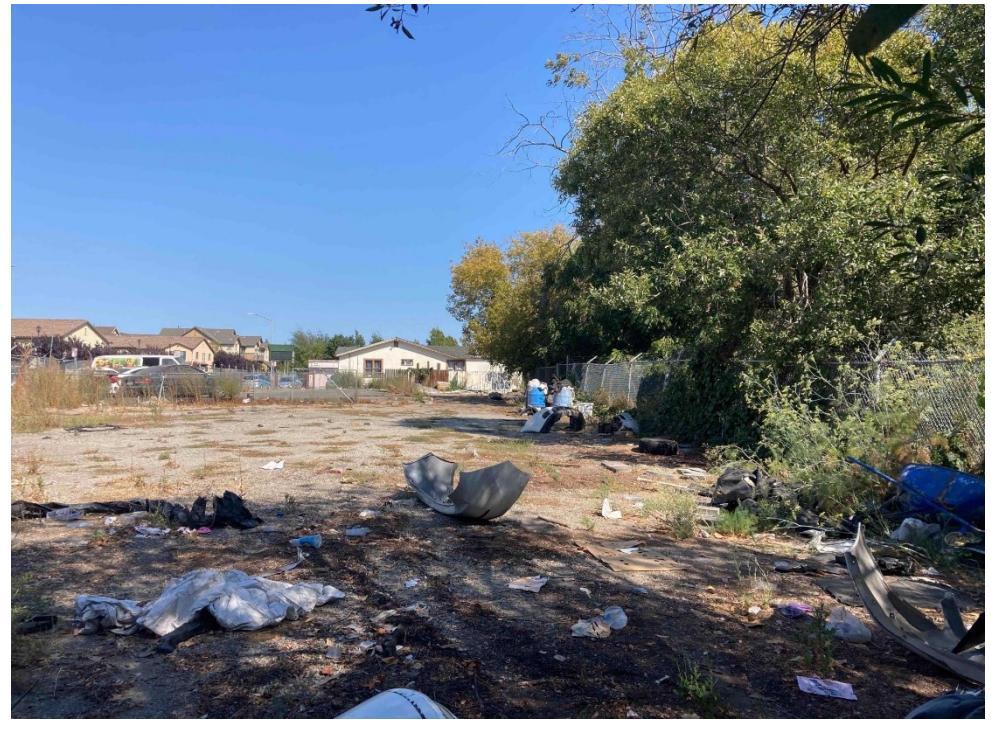
Photograph 5. Overview of site from the western end, showing house, shed, edge of riparian woodland at right, and graveled lot, facing east.

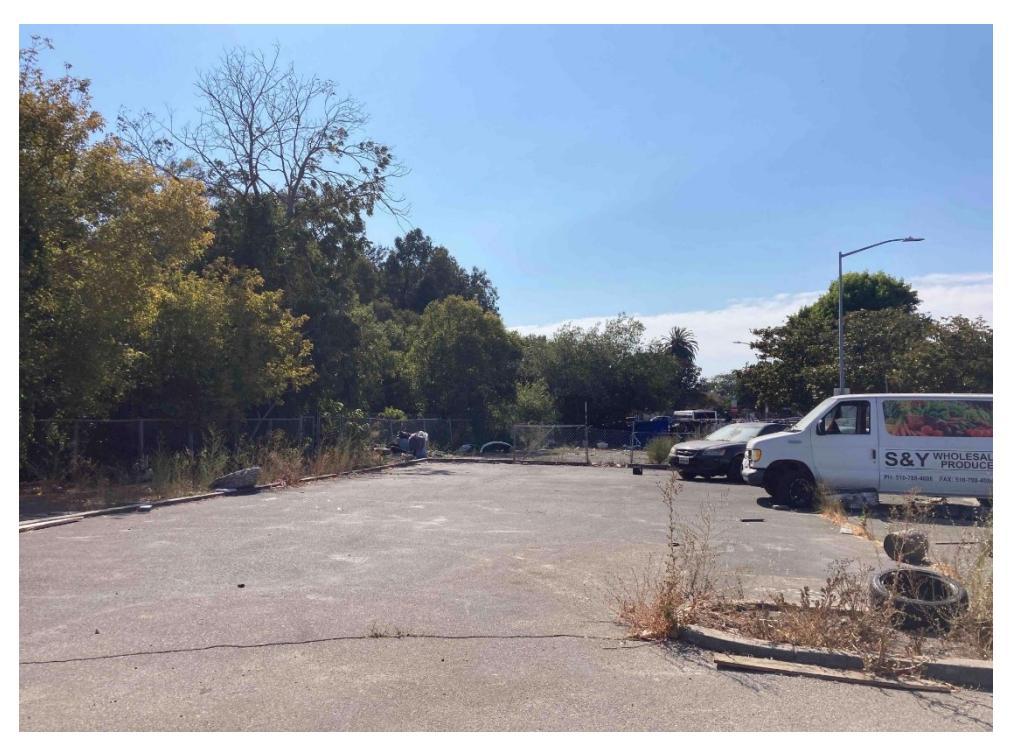
Photograph 6. Overview of western half of site, including edge of riparian woodland at left, paved lot, and graveled lot beyond, facing west-southwest.
